Thermal Control System Corrosion Study

Robert Yee, Rolfe A. Folsom, and Phillip E. Mucha

February 1990

Robert Yee, Rolfe A. Folsom, and Phillip E. Mucha
Ames Research Center, Moffett Field, California

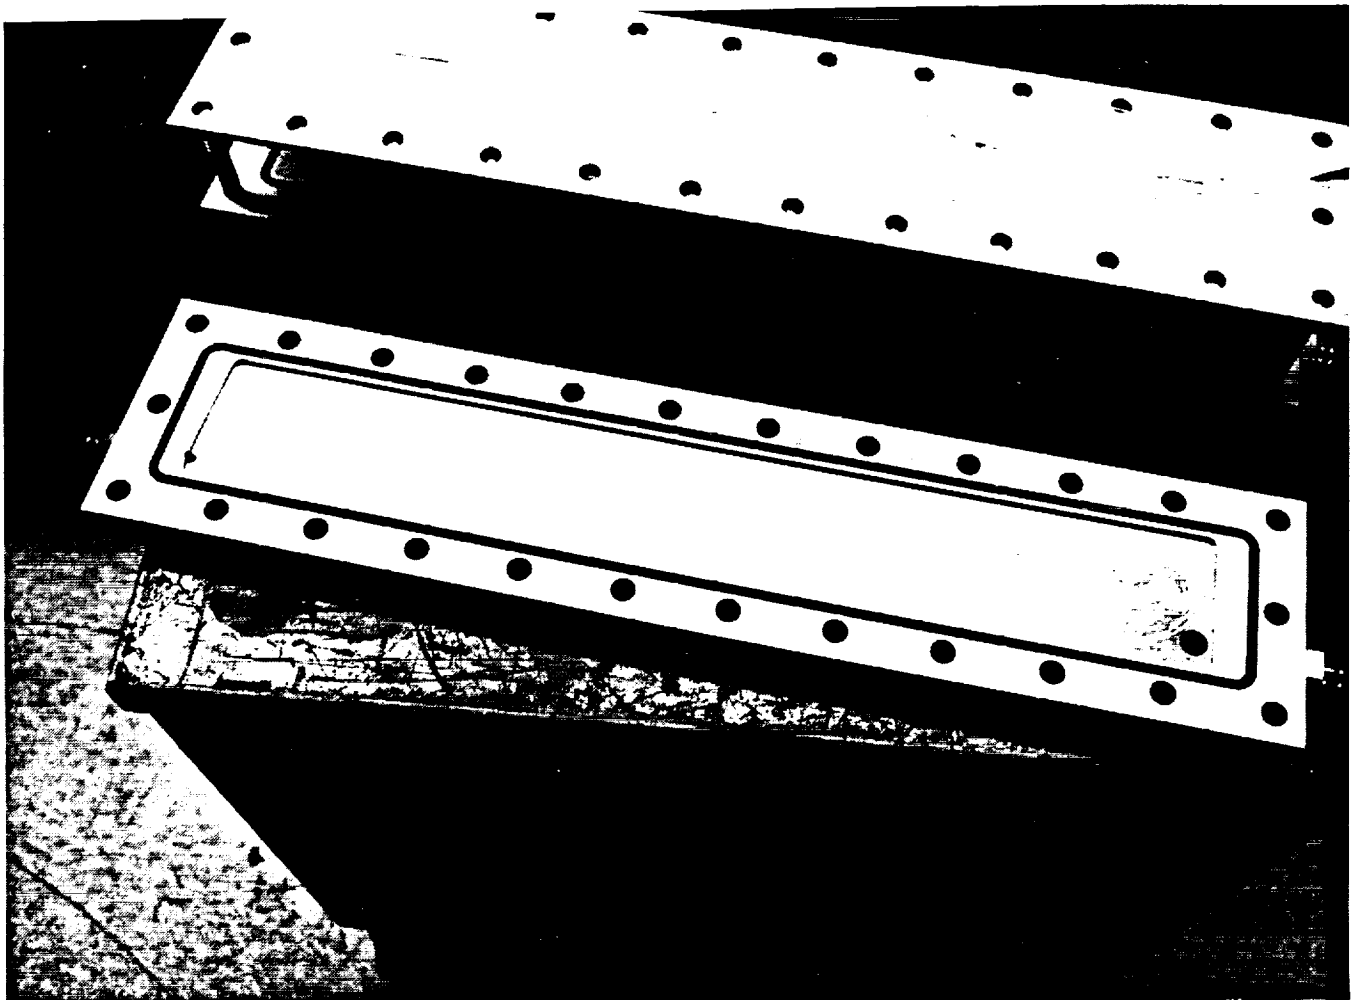
Condenser 2 was removed from the system and disassembled for O-ring replacements. Inspection of the ammonia side of the condenser revealed corrosive pitting of the aluminum surface (fig. 3). The corrosion is more pronounced around the ammonia entrance, diminishing towards the exit. Figure 4 shows deposits of residue and figure 5 shows pitting along the condenser grooves.

Figure 3.- Condenser no. 2 ammonia entrance and exit pitting.

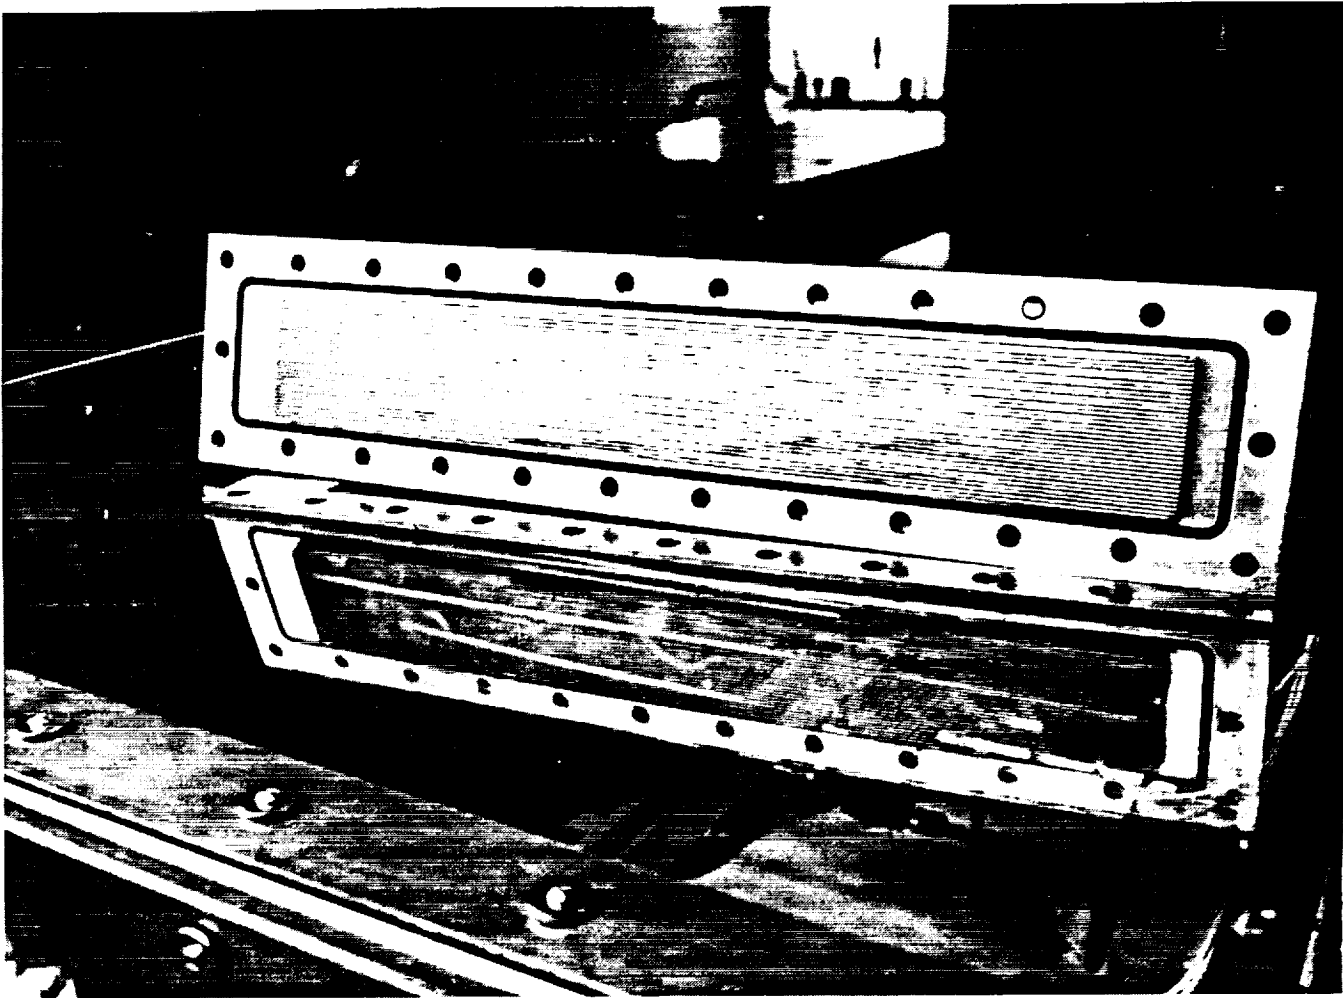
Figure 4.— Condenser no. 2 residue.

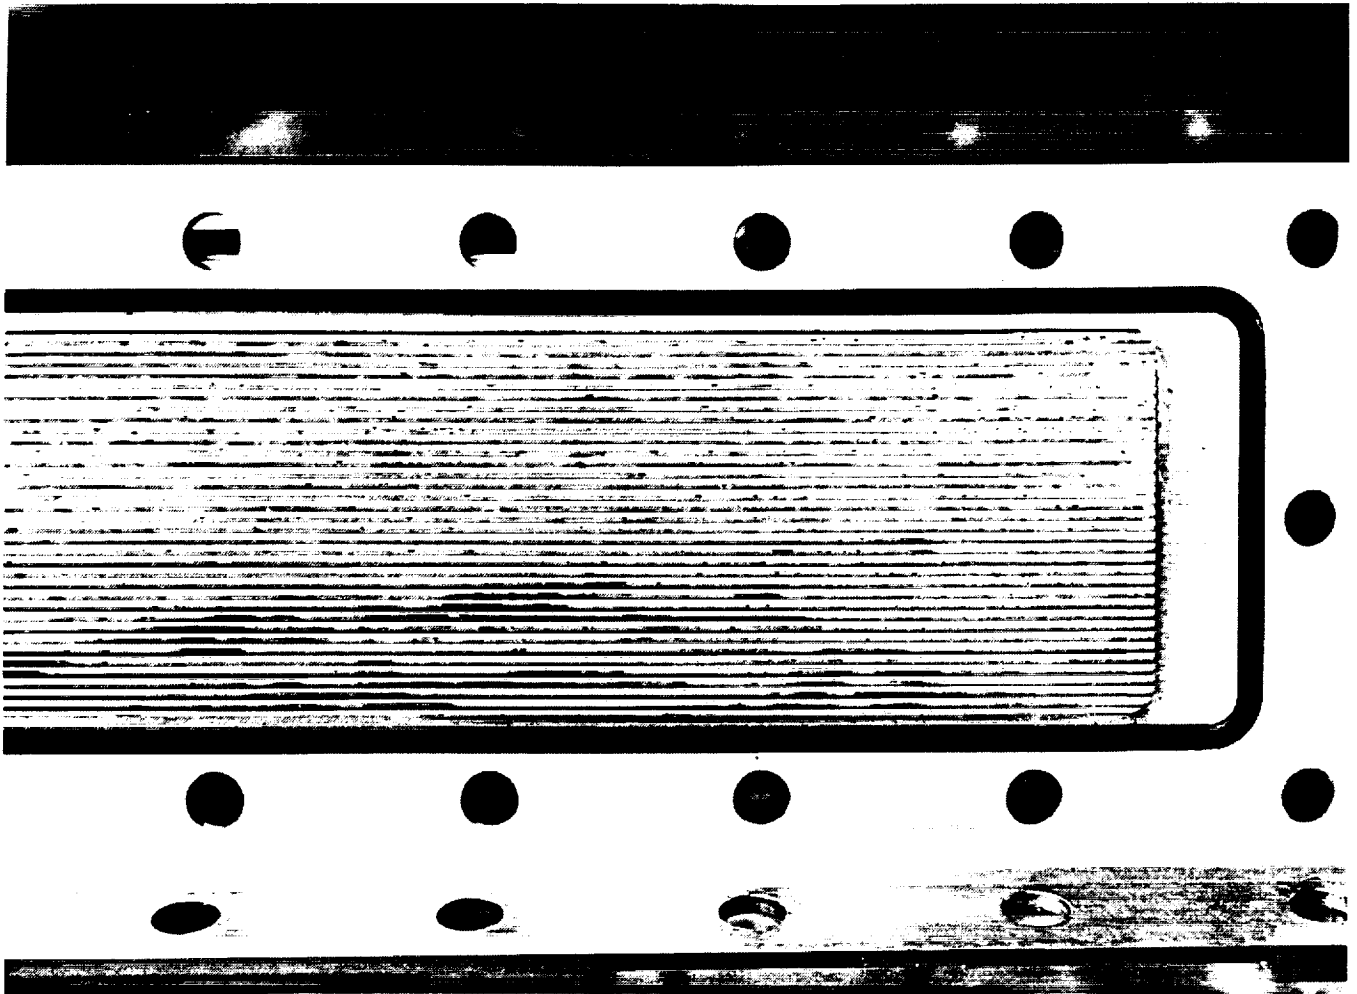
Figure 5.— Condenser no. 2 pitting.

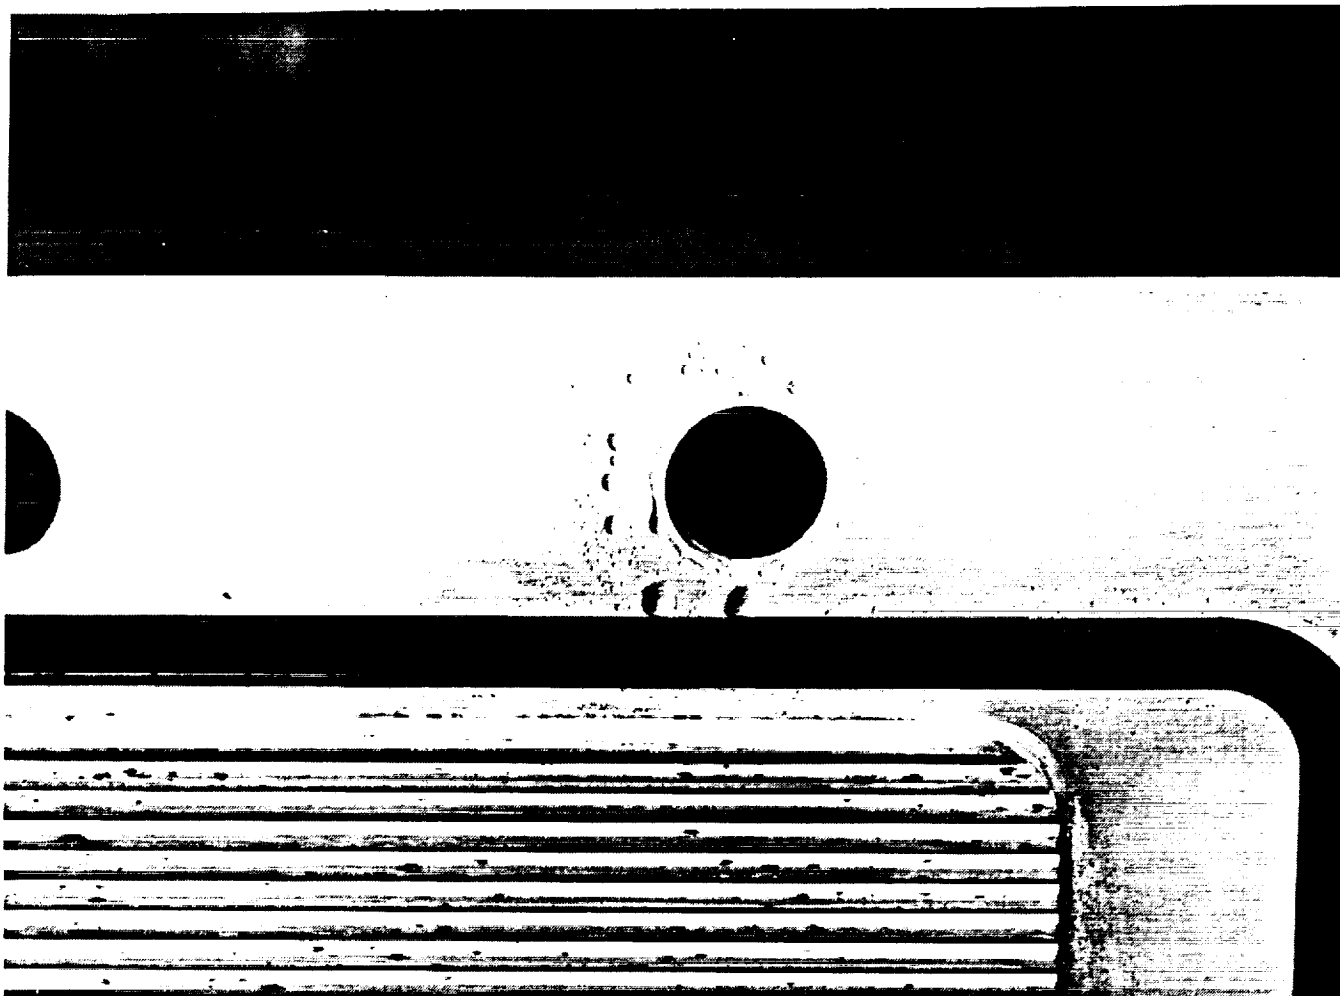
Coolant residue showed a possible leak path that enabled coolant to penetrate the metal plates that isolate the ammonia from the coolant (fig. 6). Failure of the coolant O-ring could have allowed the methanol-water mixture to bypass the metal barriers by seeping through bolt holes and into the ammonia if the O-ring on the ammonia side of the condenser also failed.

Figure 6.— Condenser no. 2 coolant leak path.

Condenser 2 is a Boeing-designed heat exchanger utilizing EPR O-rings. The failure of these O-rings and a design that allowed coolant to seep through bolt holes resulted in water contaminating the ammonia. Future condenser designs should not allow coolant to flow so freely between the ammonia and coolant sides in the event of an O-ring failure.

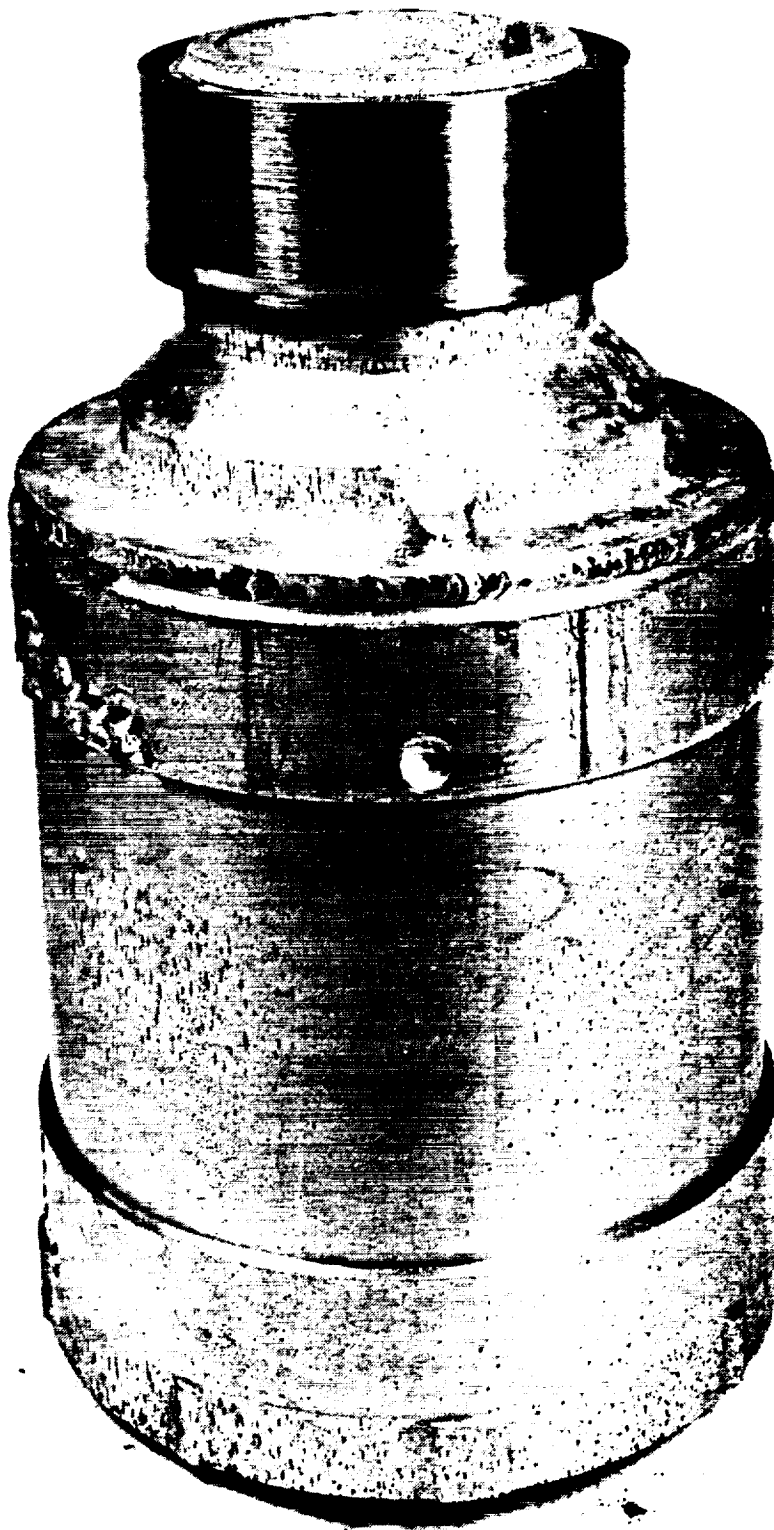
The rotating drum (figs. 7 [-70] and 8) and other bare aluminum parts showed considerable pitting on all surfaces. The interior of the rotating drum (figs. 9 through 11) was pitted and covered with the gray metallic residue similar to that found in the system filters.

Figure 8.- Rotating drum (-70), exterior.

All bare aluminum surfaces and components exhibited signs of corrosion; stainless steel and anodized aluminum components did not exhibit this corrosion. The degree of corrosion on the bare aluminum RFMD rotating drum appears to be a major contributor to the residue contamination. Similar thermal systems at Johnson Space Center and Boeing have not exhibited this corrosion. Their rotating drums have been either anodized or chem-filmed.

From the Ames analysis and the analysis of other users, it is strongly recommended that all bare aluminum surfaces be coated with a material that provides a barrier to the corrosive ammonia. Alodining would be the preferred choice, followed by anodizing and (nickel and chrome plating) using Armoloy.

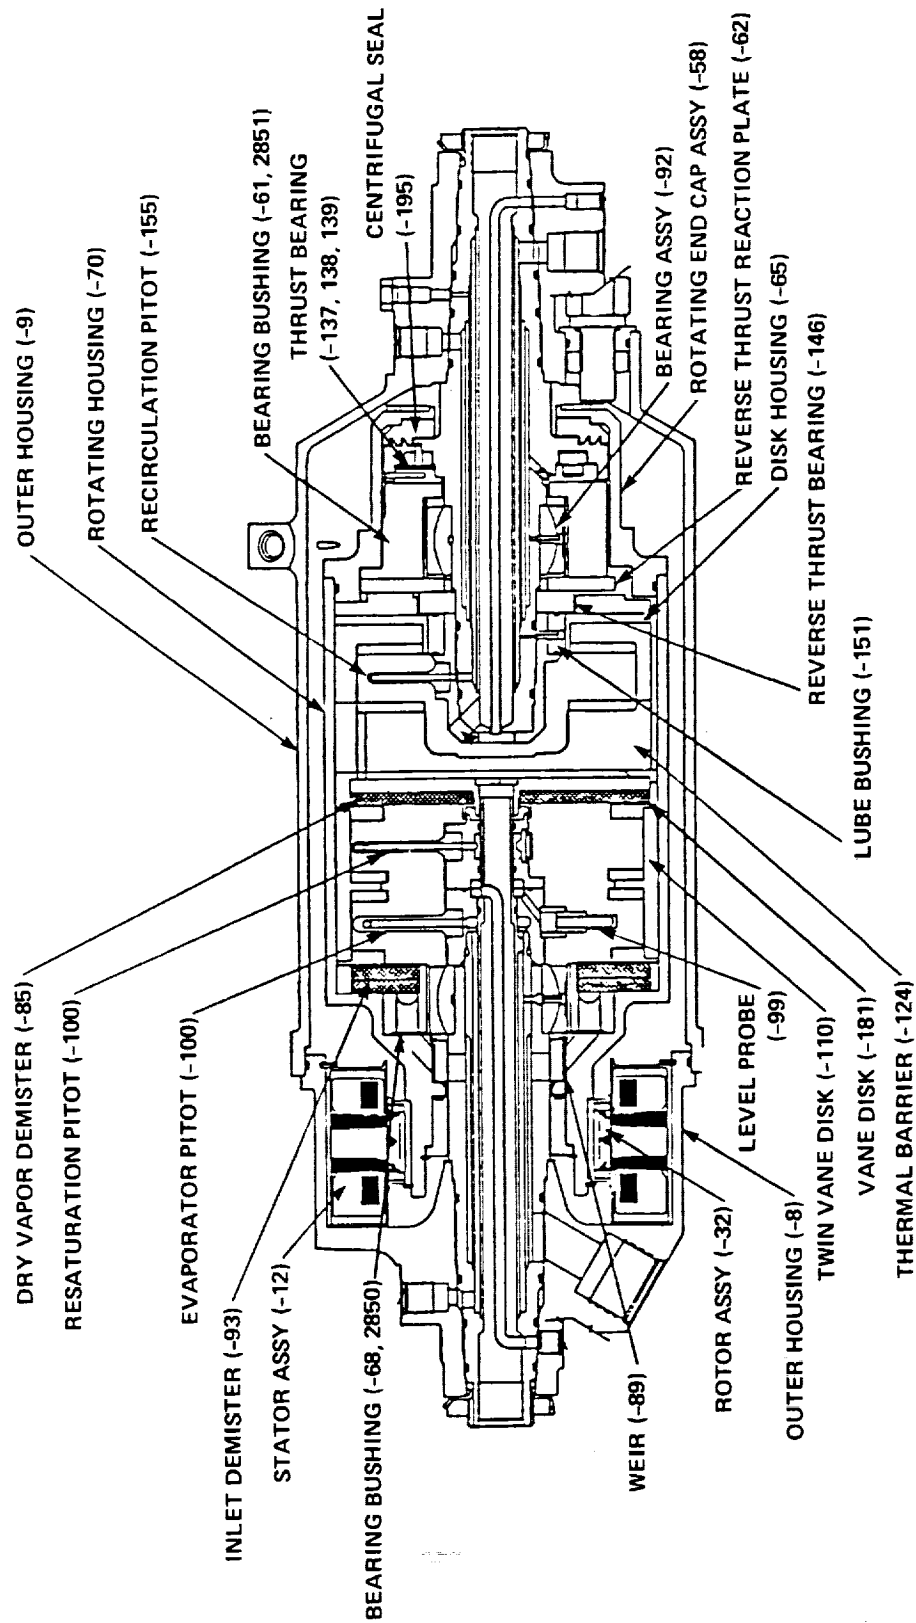
Figure 7.- Rotary fluid management device (U.S. Patent No. 4,603,732).

The RFMD was sent to Sundstrand for teardown inspection, cleaning, repairs, and reassembly (refs. 8 and 9). The cutaway view of the RFMD in figure 7 illustrates the components mentioned in the inspection findings.

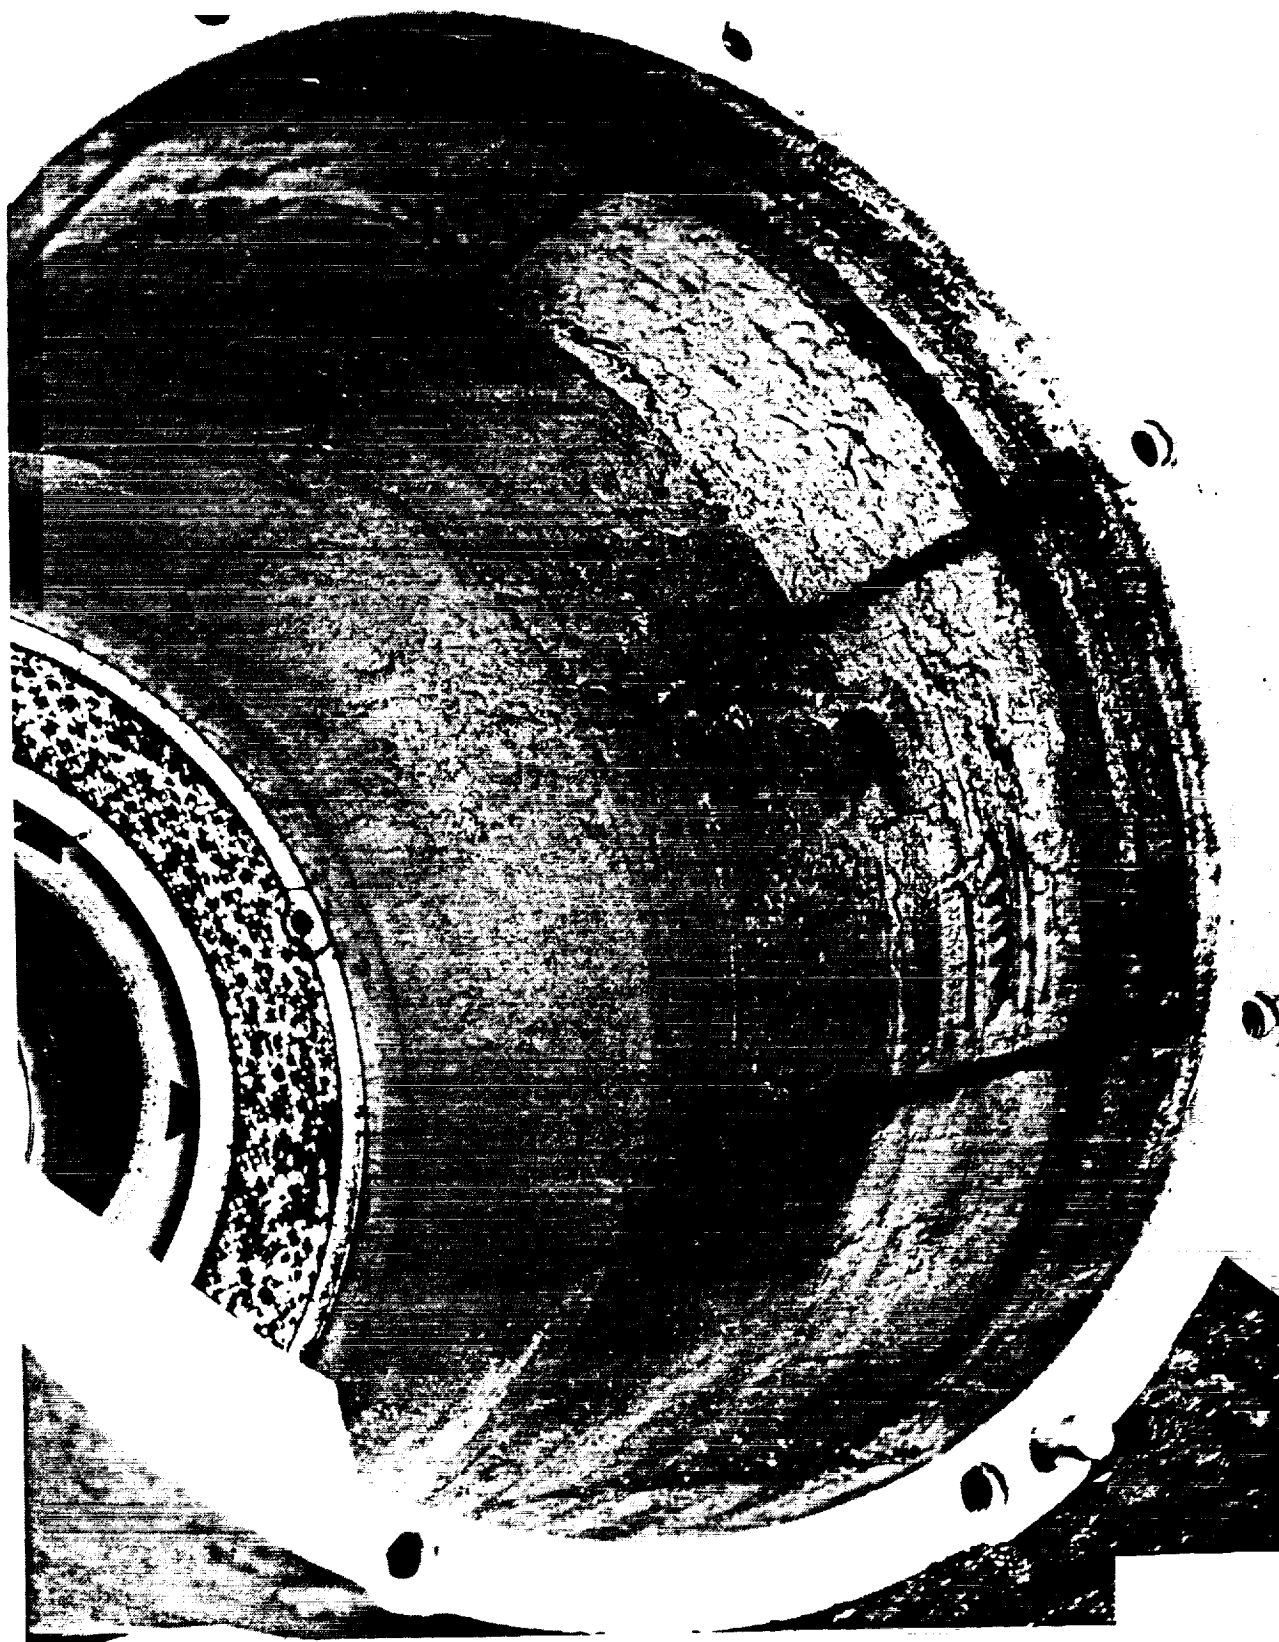
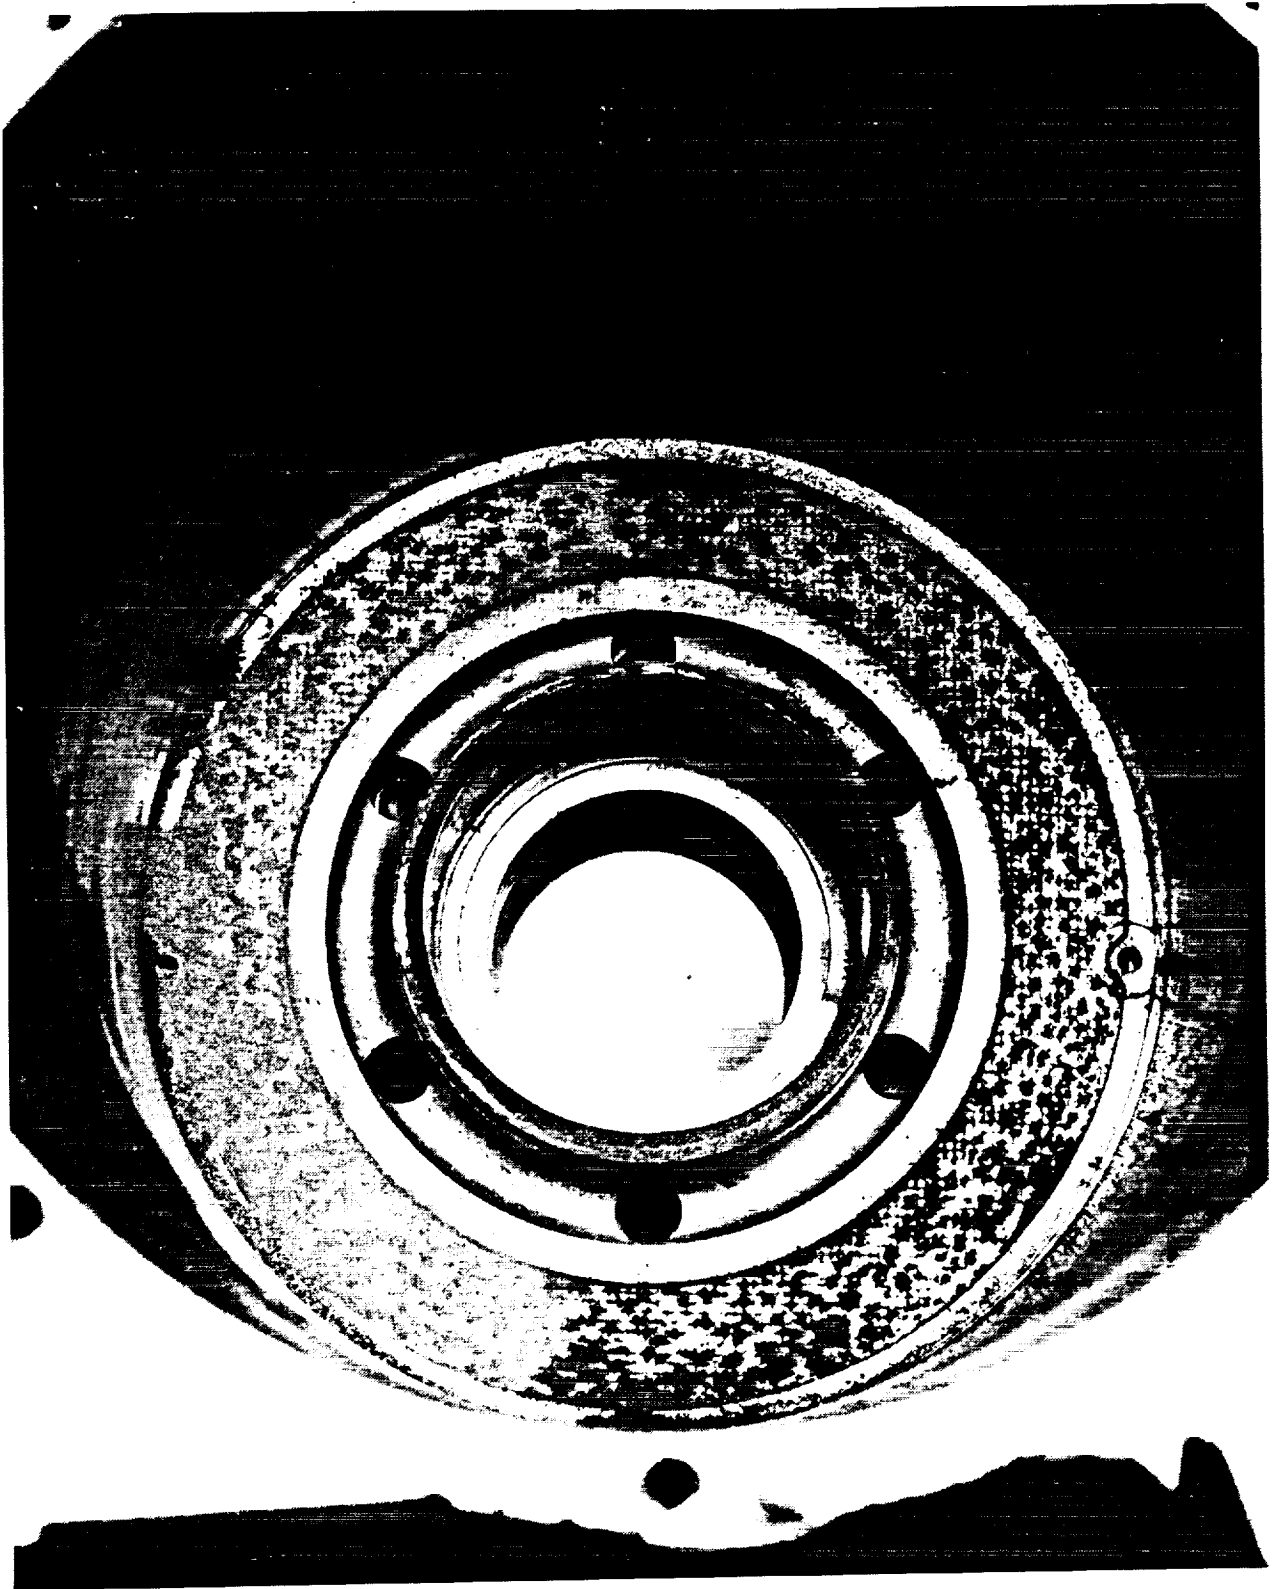
Figure 9.— Pitting of rotating drum (-70).

Figure 10.— Rotating drum (-70), inner wall.

Figure 11.- Rotating Drum (-70), interior.

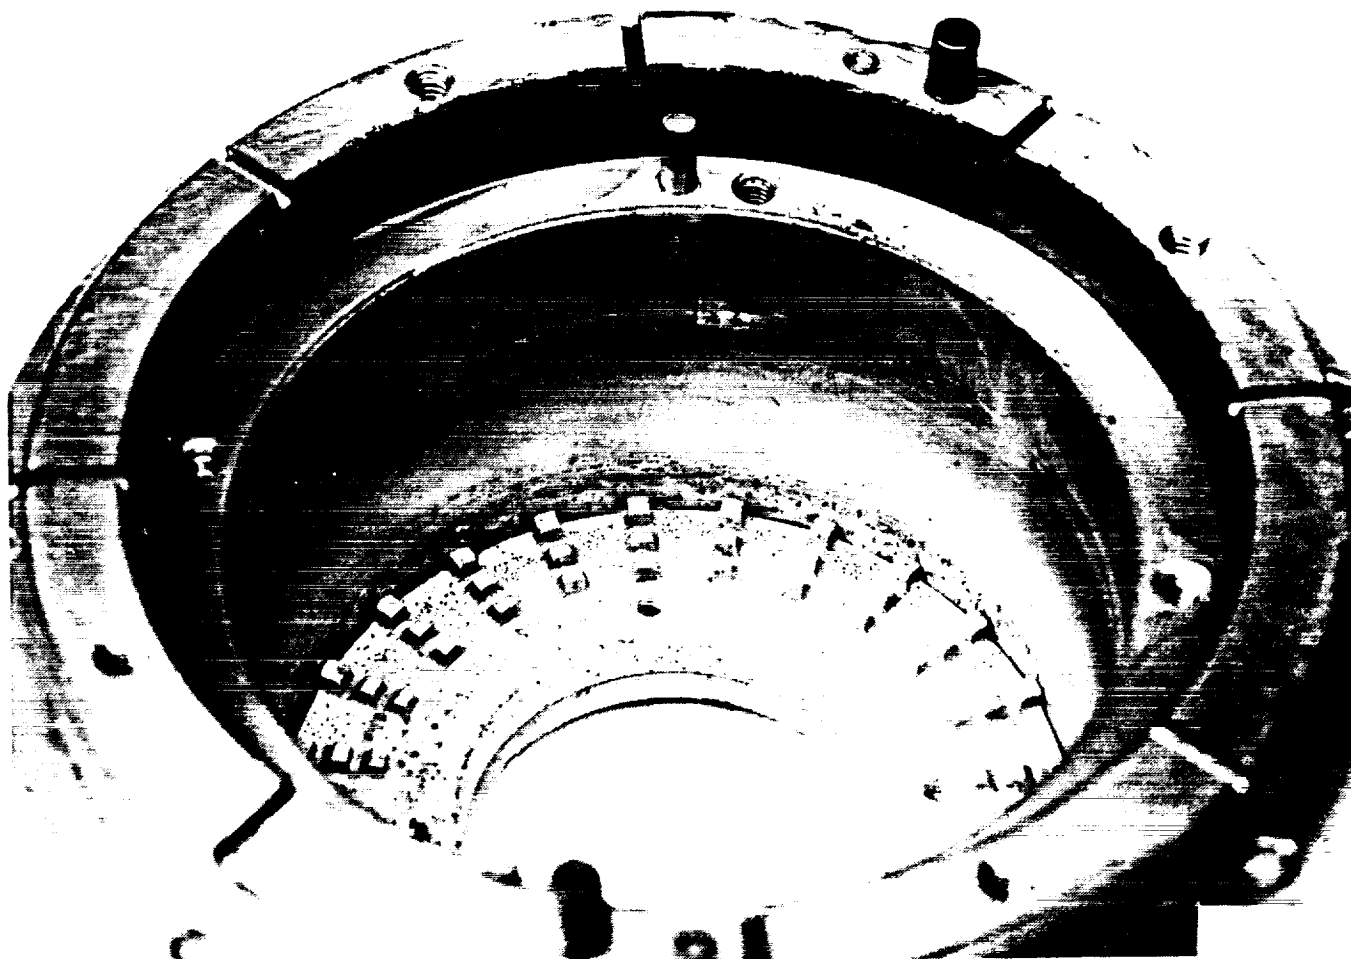
The rotating housing end cap (figs. 7 [-58] and 12) was anodized and showed corrosion only where the anodized coating was not present. Figure 12 also shows the centrifugal seal corrosion (fig. 7 [-195]) is similar to that on the rotating housing. The anodized aluminum parts, such as the vane disk (figs. 7 [-181] and 13), exhibited no sign of corrosion.

Figure 12.—Rotating housing end cap assembly (-58) and centrifugal seal (-195).

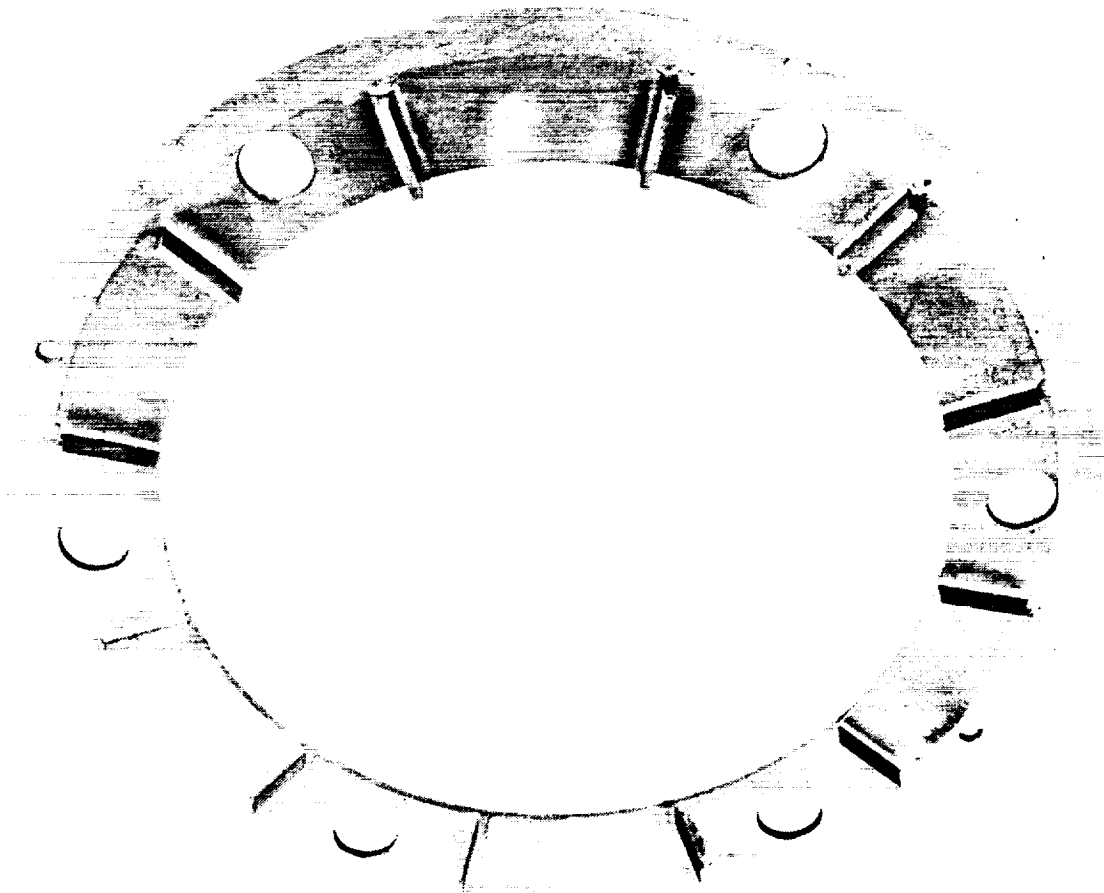
Figure 13.- Vane disk (-181).

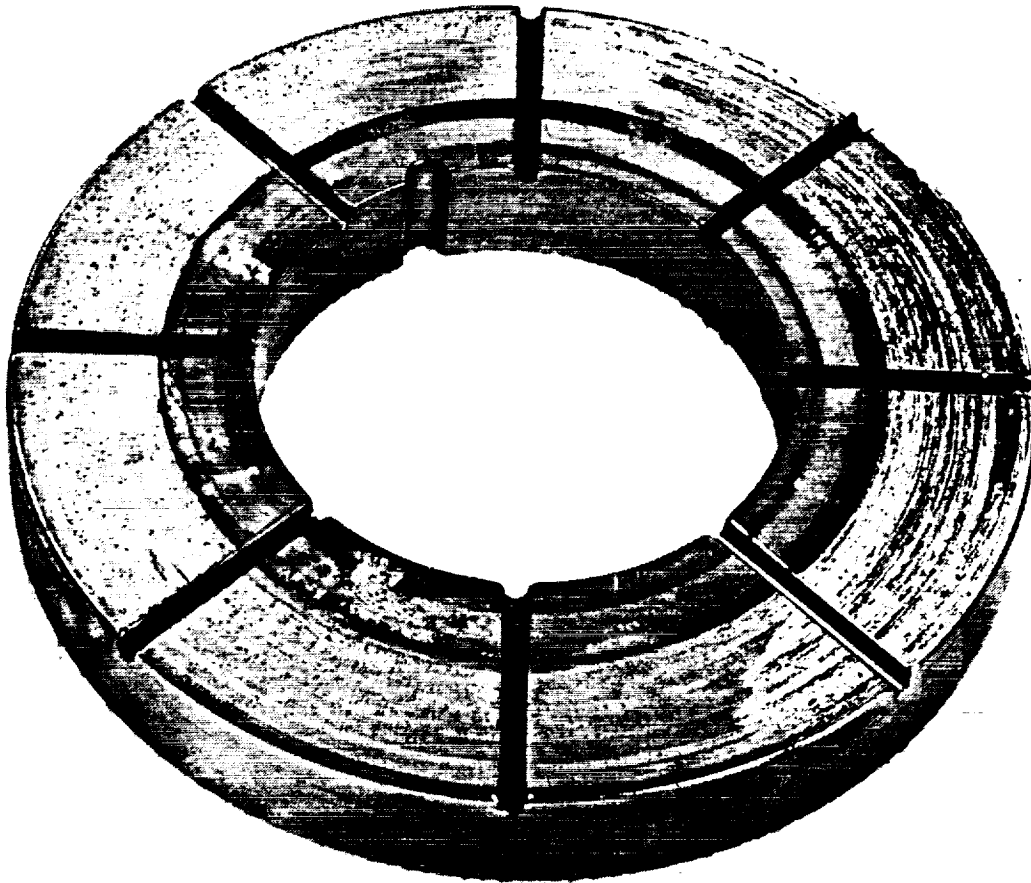
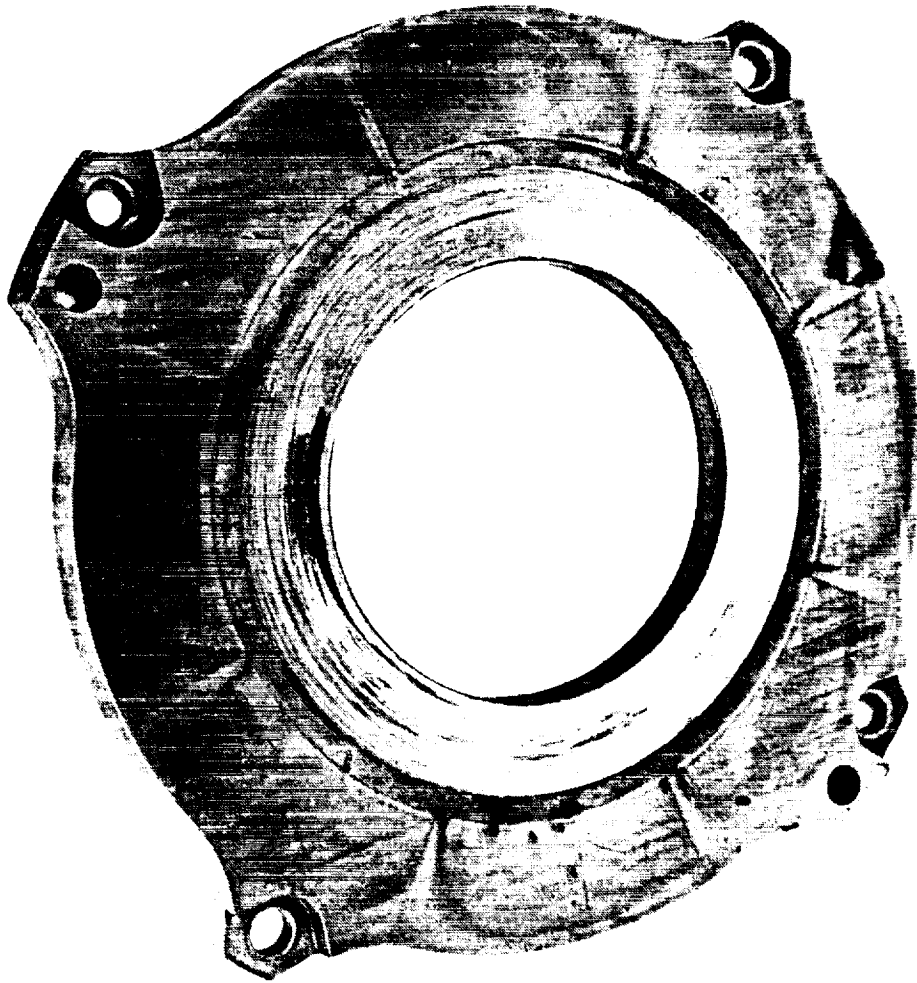
The reverse thrust bearing (fig. 14) and mating surface (fig. 15; also fig. 7 [-146, -62]); showed signs of excessive wear. The electroless nickel/Teflon coating on the bearing was completely worn off and the bearing was scored.

Figure 14.- Reverse thrust bearing (-146).

Figure 15.- Reverse thrust bearing reaction plate (-62).

The reverse-thrust bearing Teflon coating on the Brassboard was completely worn through. As a result, the bearing and mating surface showed excessive wear. Sundstrand recommends the Teflon reverse thrust bearing be replaced with a carbon reverse thrust bearing.

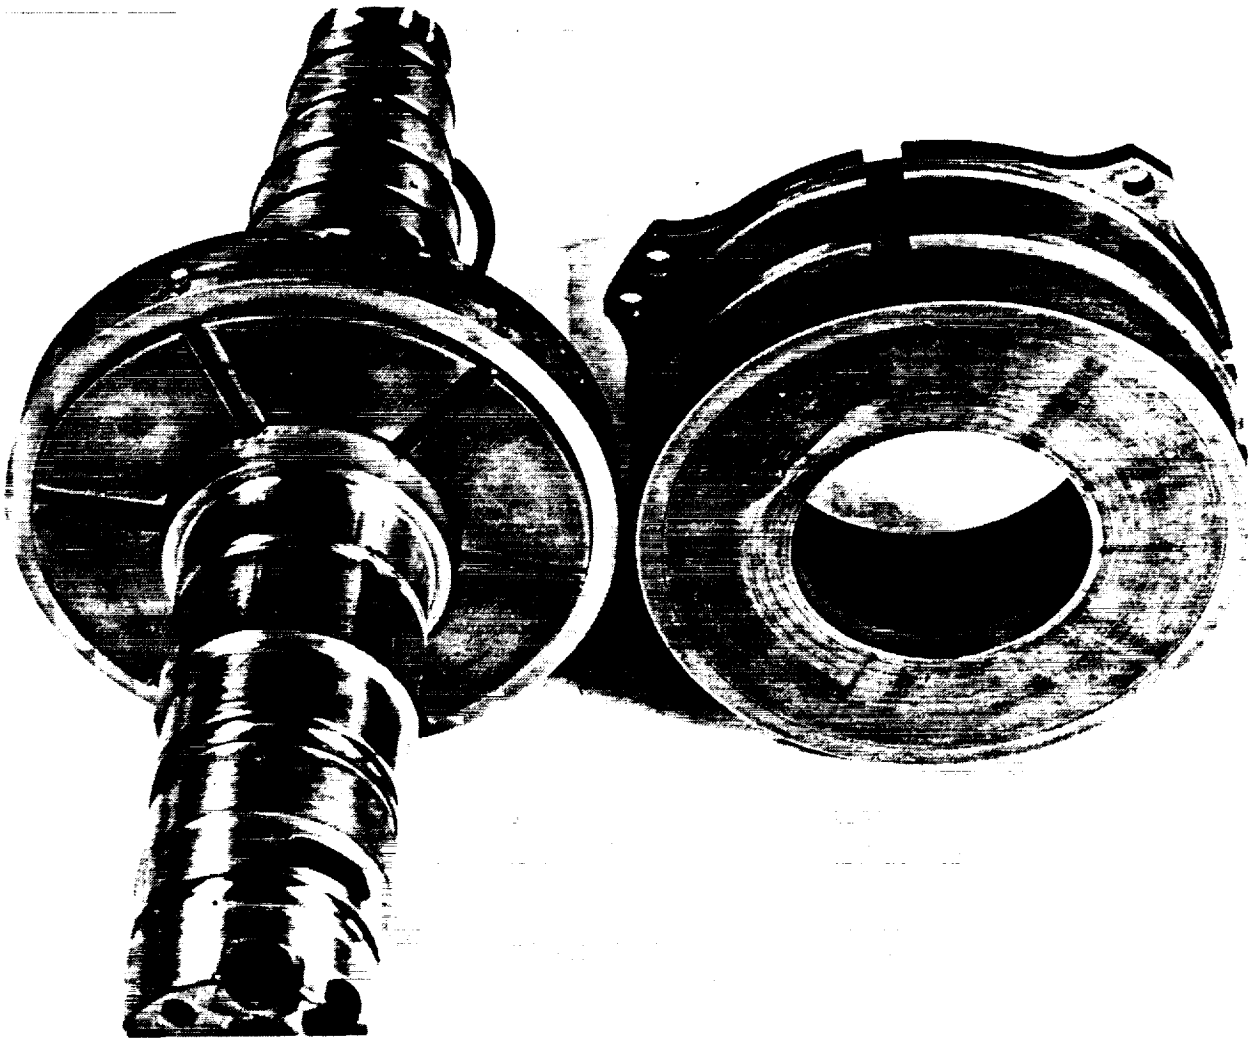
The thrust bearing and mating surface (figs. 7 [-137, 138, 139] and 16) showed no sign of wear or corrosion.

Figure 16.- Thrust Bearing and Thrust Bearing Surface (-137, 138, 139)

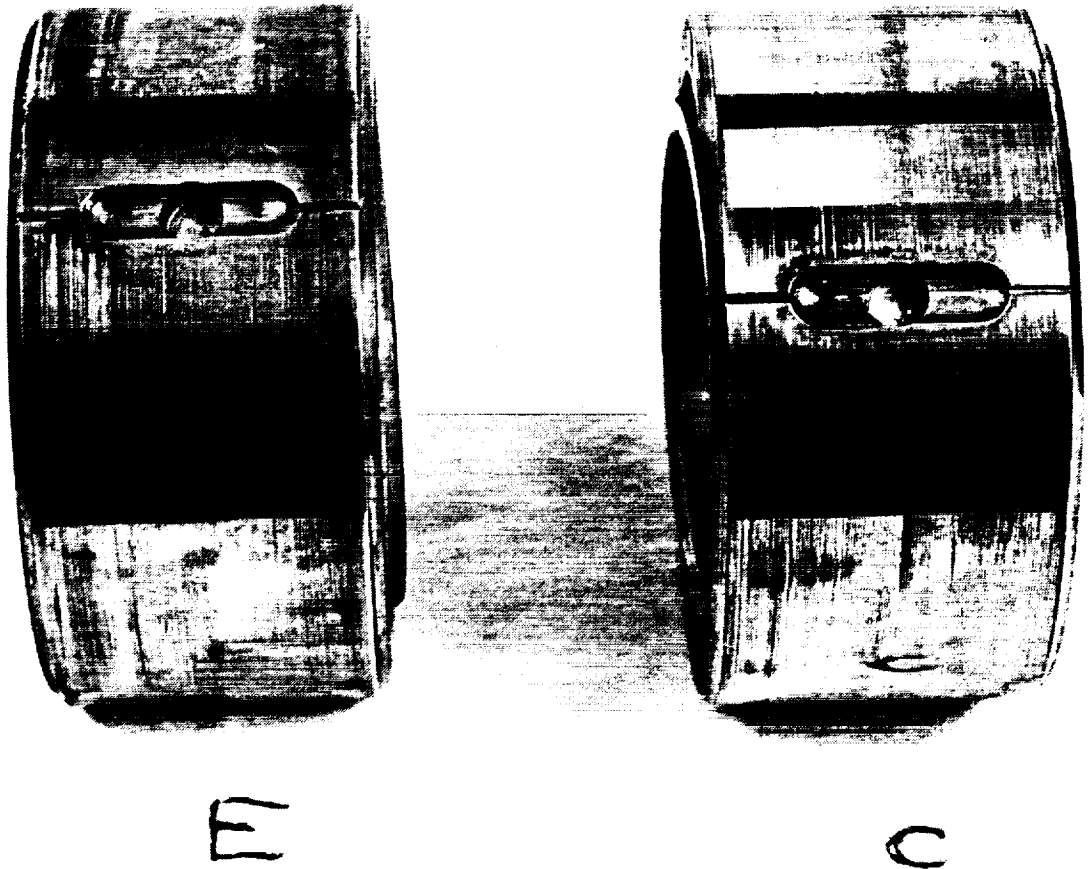
The condenser end and evaporator end radial bearings (figs. 7 [-92] and 17) displayed no sign of wear or corrosion. Furthermore, the carbon-lined bearing bushing (figs. 7 [-61] and 18) showed almost no sign of wear. The evaporator end bearing and bearing bushing conditions were surprisingly good despite the residue clogging the filter screen, which severely restricted the lubrication supply (fig. 19).

Figure 17.— Radial bearing (-92).

Figure 18.- Bearing bushing (-61).

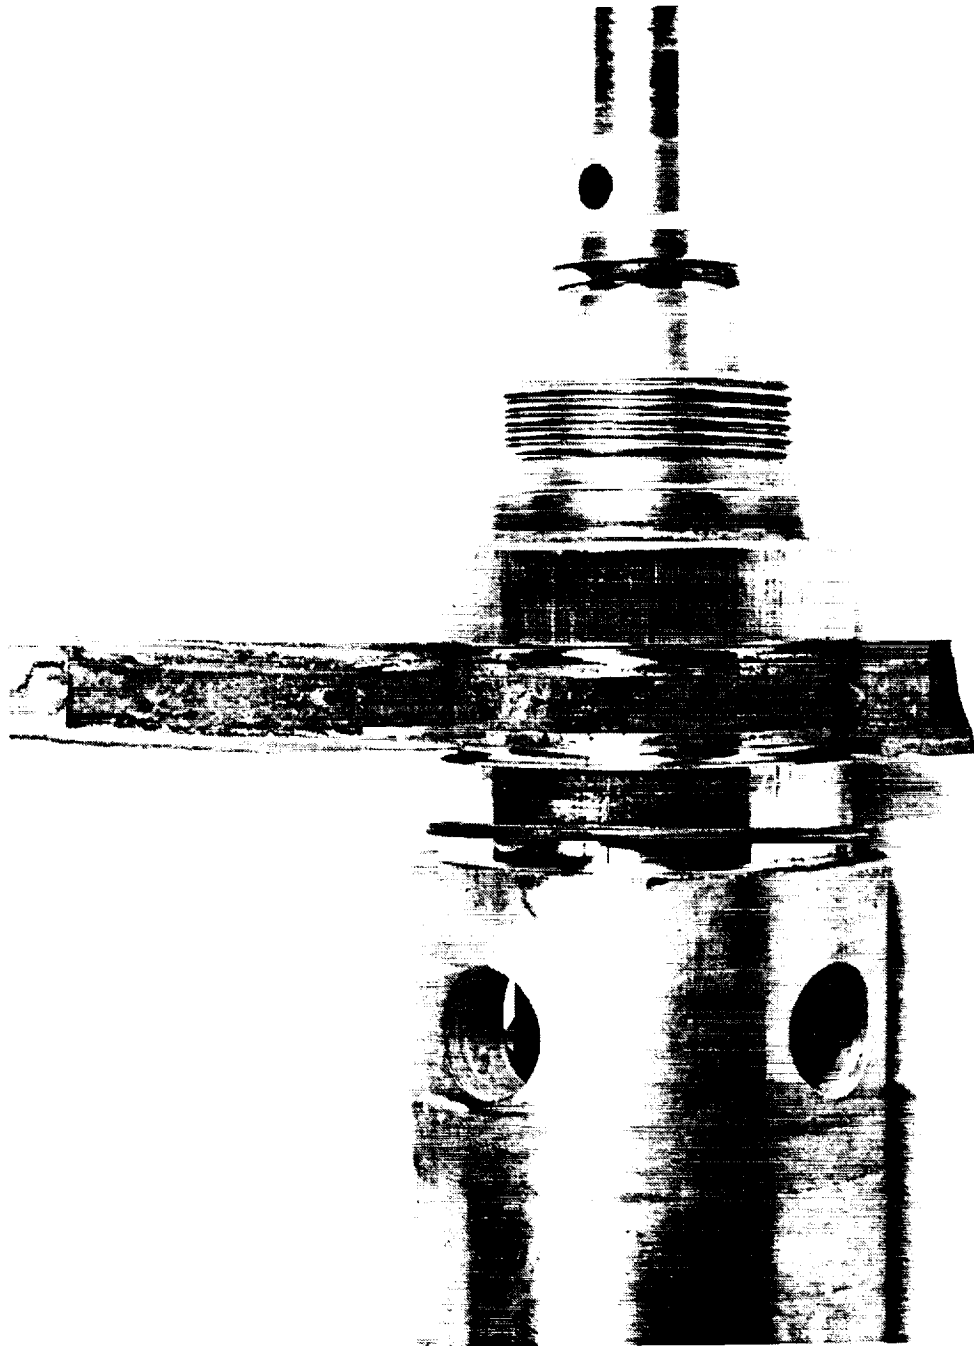
The degree of residue contamination found within the RFMD was high enough to show the robustness of the RFMD in maintaining proper thermal system operations. The evaporator bearing feed-flow filter screen internal to the RFMD showed significant clogging (fig. 19) and very restricted bearing flow. Contaminant residue had penetrated the filter screen and coated the bearing. The bearing and mating surface exhibited no signs of scoring.

Figure 19.— Evaporator shaft and evaporator-bearing feed flow filter screen.

The internal evaporator bearing feed flow-filter screen should be eliminated. If the contamination residue is present in the RFMD, there is a greater danger of bearing damage resulting from insufficient fluid flow than from residue abrasion on the bearing.

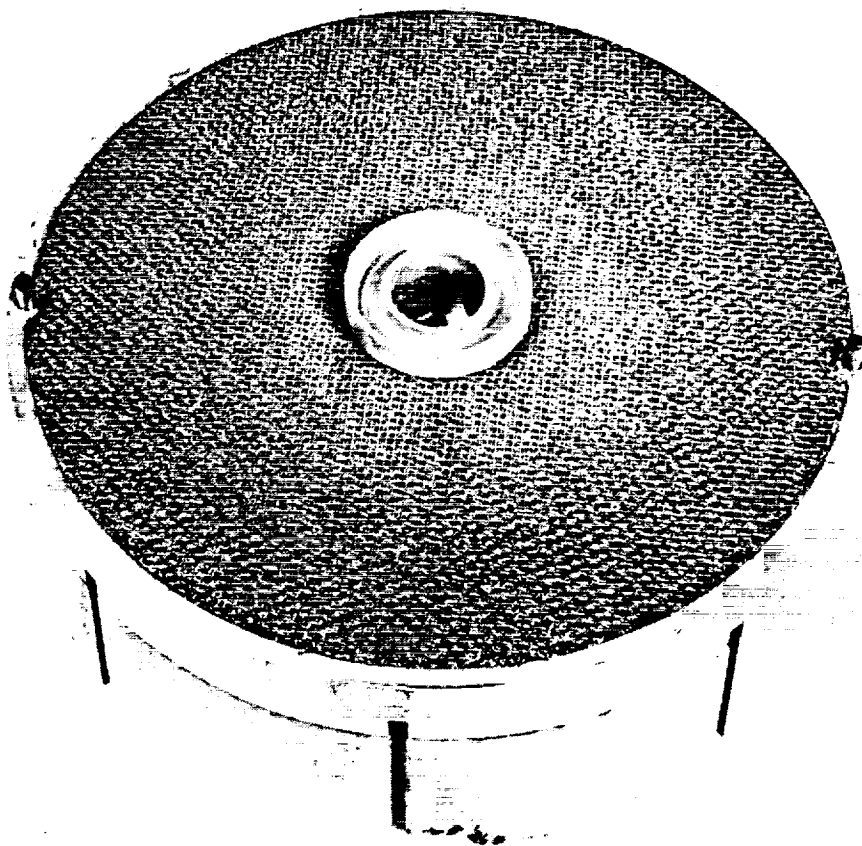
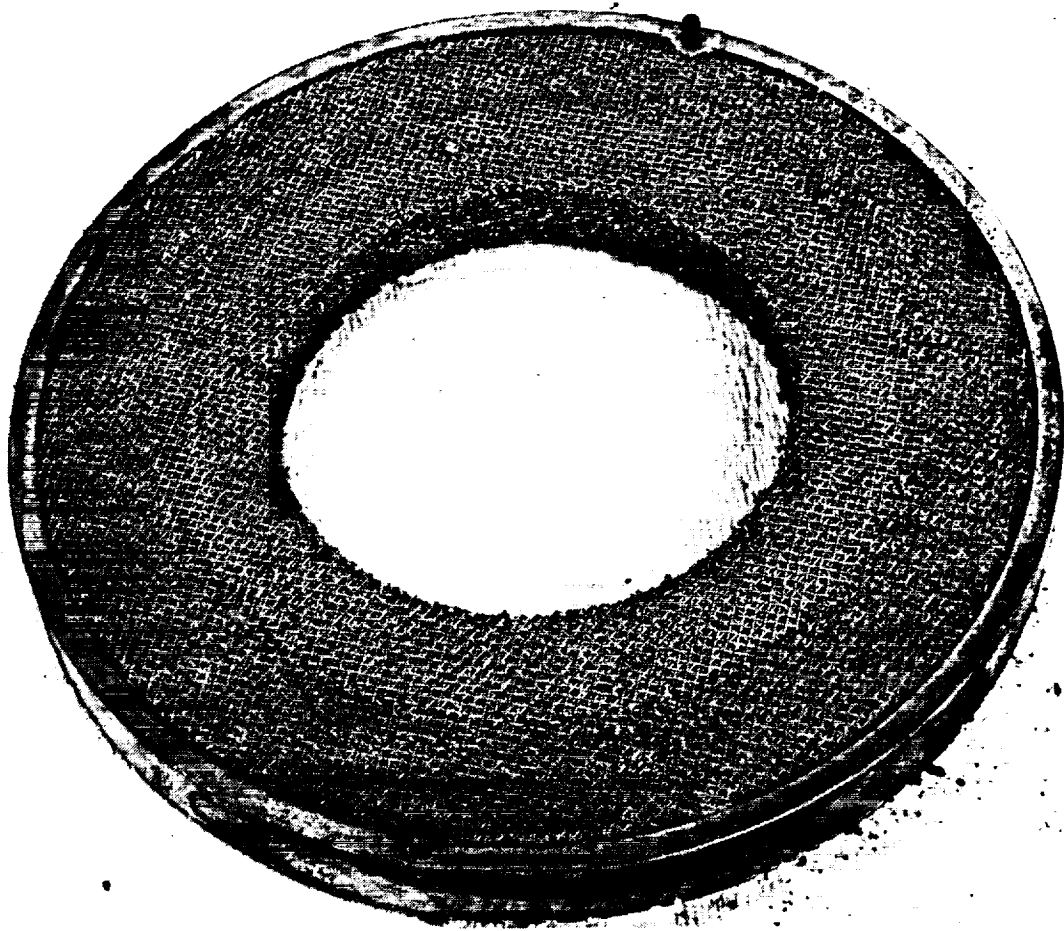
The demisters (figs. 7 [-85, 93], 20, and 21) are fabricated from a stainless steel mesh which showed no sign of corrosion but were contaminated with a considerable amount of residue. The demister chem-filmed aluminum housings exhibited very little evidence of corrosion.

Figure 20.— Vapor outlet demister (—85).

Figure 21.— Two-phase return demister (—93).
